**MONITORING COMPLETED COASTAL PROJECTS PROGRAM**

MISCELLANEOUS PAPER CERC-91-5

**SPUD POINT MARINA BREAKWATER, BODEGA BAY  
SONOMA COUNTY, CALIFORNIA**

Final Report

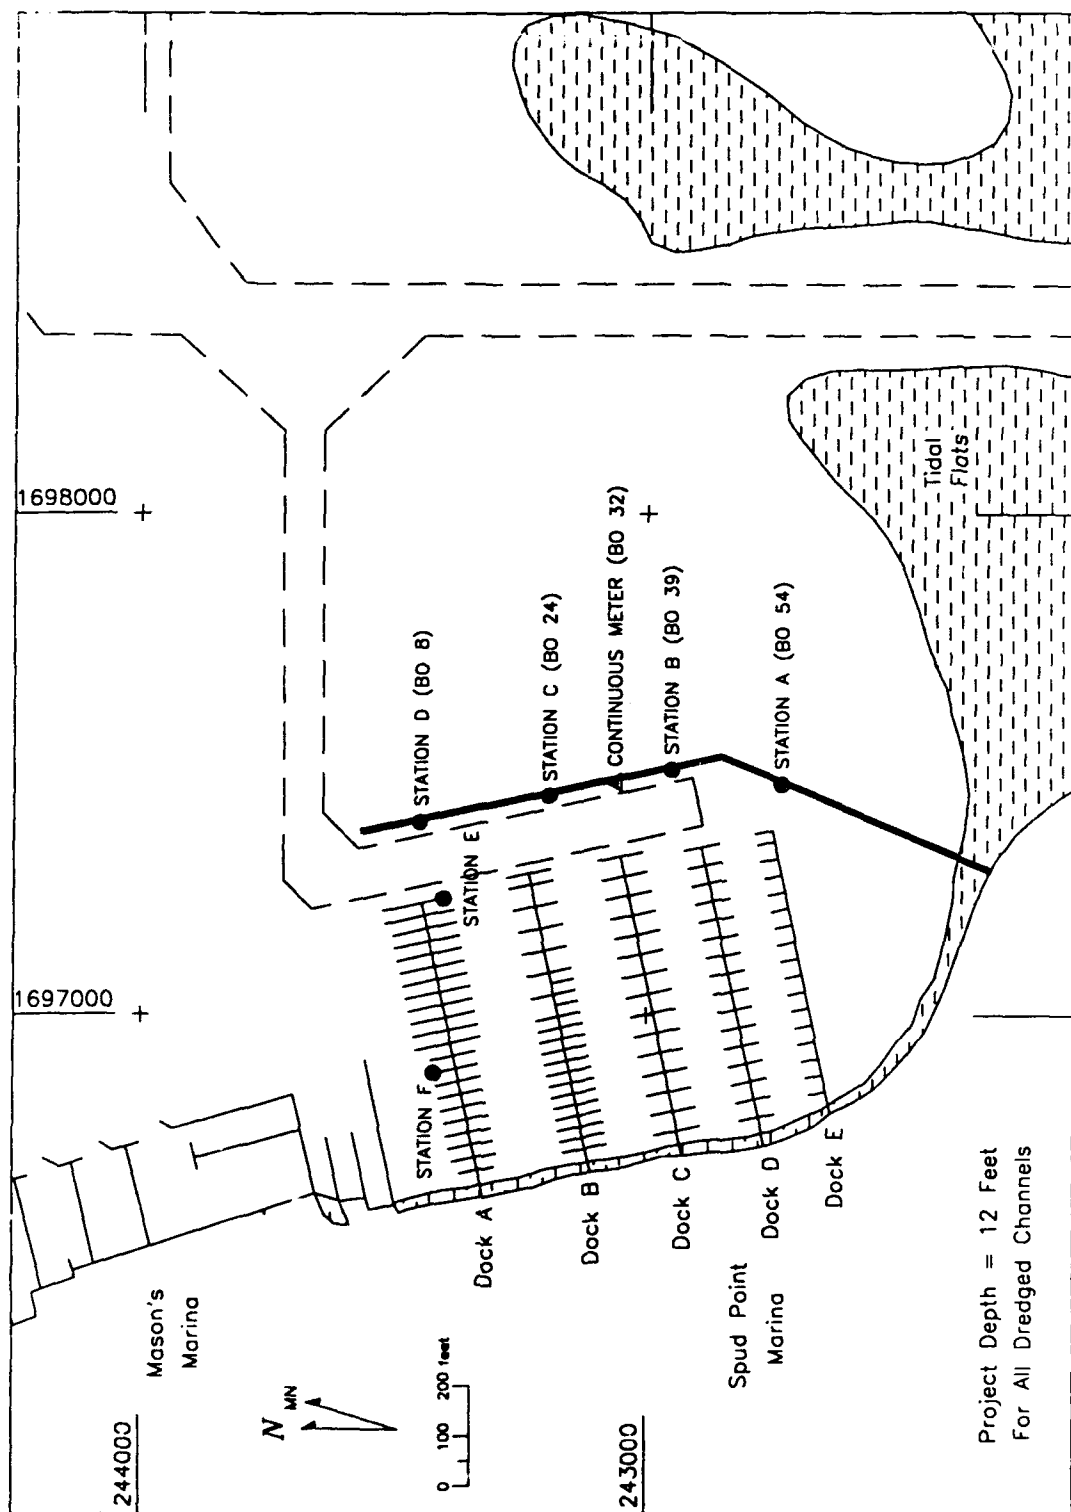
Current profile measurement stations A through F were selected at sites along the breakwater and north side of the marina as shown in Figure 11. Sites A through D were located adjacent to baffle openings; the figure gives the sequential baffle opening number (numbers start at the first opening at the north end of the breakwater) for these stations. A series of hourly measurements of horizontal velocity were obtained over the 25-hr period (one tidal cycle) from approximately 11:00 Pacific Standard Time (PST) on 9 March through 12:00 PST on 10 March, with three readings taken over the water column at each site. For stations B, C, and D, the readings were taken at 2 ft above the bed, at the center of the baffle opening, and at 1 ft below the bottom edge of the baffle panel. At station A, only a single reading was taken during each round of sampling, due to the small height of the baffle opening there. At stations E and F, the bottom

Figure 11. Current measurement stations

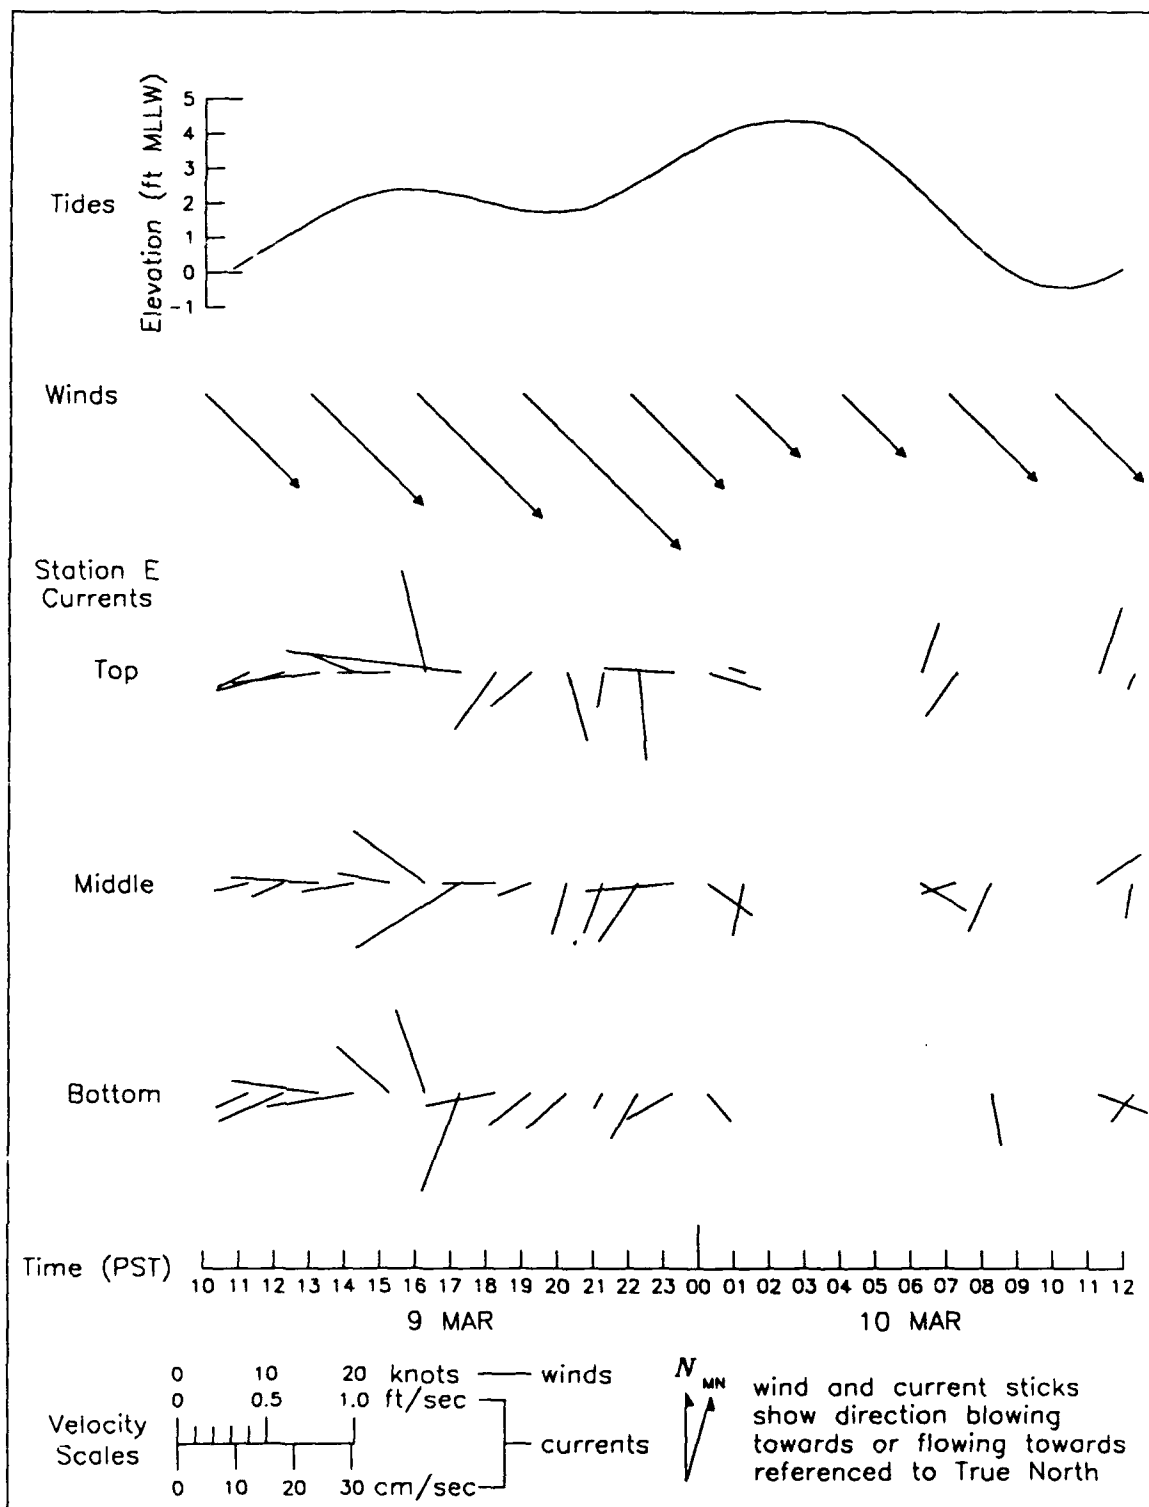
Figure 12 shows measured tide, winds, and station E currents versus time during the profile study. The tide plot is a smooth curve fit to the observed data. The wind data are shown as vector velocities, as are the current data. Figure 12 allows a comparison of the currents with the major driving forces, and also shows the depth variation. As can be seen in the figure, the winds were relatively strong and steady from the northwest, but the current direction appears to be more strongly dependent on the tide than on the winds. Current speeds lower than the threshold of the meter (no vector plotted in the figure) occur around the times of higher high water and lower low water. Current magnitudes are generally greatest at the top of the water column, and the flow is complex and somewhat stratified as indicated by the variation in direction between readings at different levels for corresponding times. Figure 13 shows the measured mid-depth current vectors for all of the stations together. Stations A - D along the breakwater showed minor depth variation, so the mid-depth values (center of baffle opening) are representative. This figure gives an impression of the site's general circulation pattern. The stations along the breakwater had a predominantly north-to-south flow throughout the 25-hr study. The data indicate that flow generally entered the marina through the breakwater during the rising tide, and seems to have exited along the northwest part of the marina. During the falling tide, the flow more closely paralleled the breakwater, but was still generally north to south. Observations near the landward end of the breakwater would be useful to further identify the circulation pattern.

Figure 12. Measured tides, winds, and station E currents versus time, 9-10 March 1988

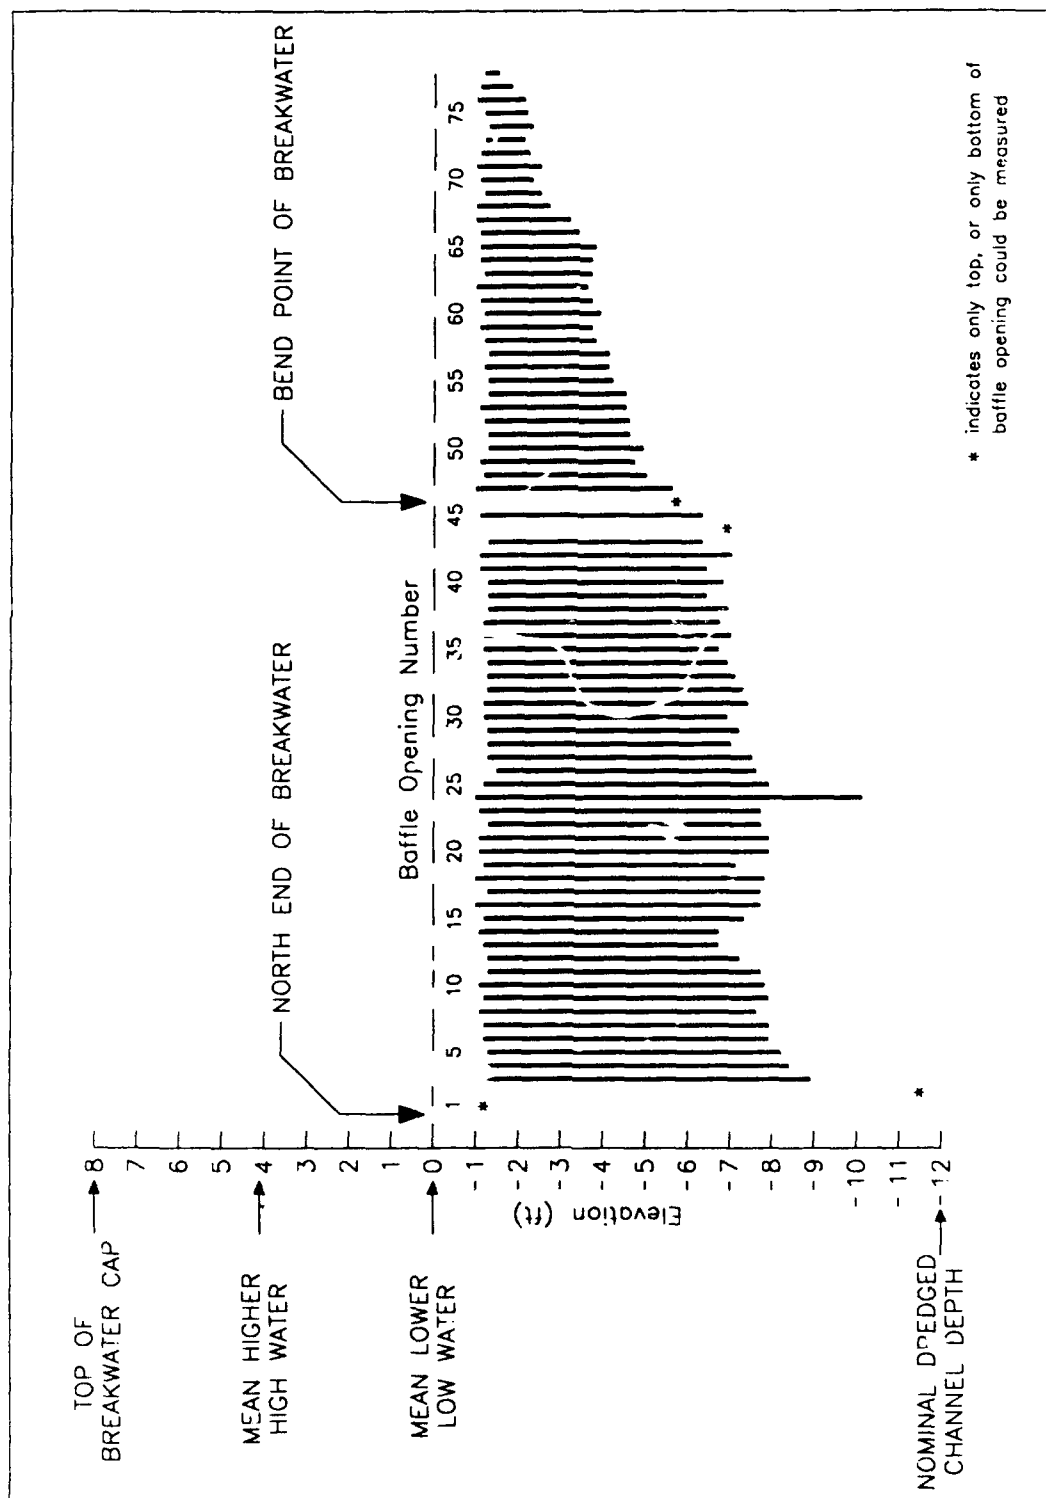
opening dimensions were also measured, by lowering an "L"-shaped graduated rod from the cap and hooking it under the bottom of each baffle panel, then lowering further until the rod touched bottom. These elevations were determined by reference to the top of the cap (assumed level at +8-ft elevation). Figure 17 shows a plot of the resulting baffle opening dimensions (dark vertical bars) versus horizontal position along the breakwater. The vertical dimensions are plotted to scale; the horizontal axis is only approximately scaled. The variation in the baffle panel bottom elevations was mostly due to varying accumulations of marine growth on the panels. The mudline elevation along the structure can be interpolated by connecting the bottoms of the baffle opening bars in Figure 17. Onsite observation found the mudline elevation to be deeper than -12 ft mllw at the seaward end and higher than -1 ft mllw at the landward end, where the baffle panel bottoms are buried. There is, however, a shallow gap at the landward end, between the end of the structure and the shore (see Figure 5b) which is open to flow during high tide. The relatively deep spot noted previously on the side-scan sonar image is seen on Figure 16 at baffle opening No. 24. The baffle opening data give no evidence of scour problems, but may be useful for comparison with future datasets. From the figure, the -7 ft mllw mudline elevation used in the wave transmission calculation seems to have been a reasonable choice for a working mudline elevation on the seaward leg of the breakwater.

Figure 17. Vertical baffle opening dimensions

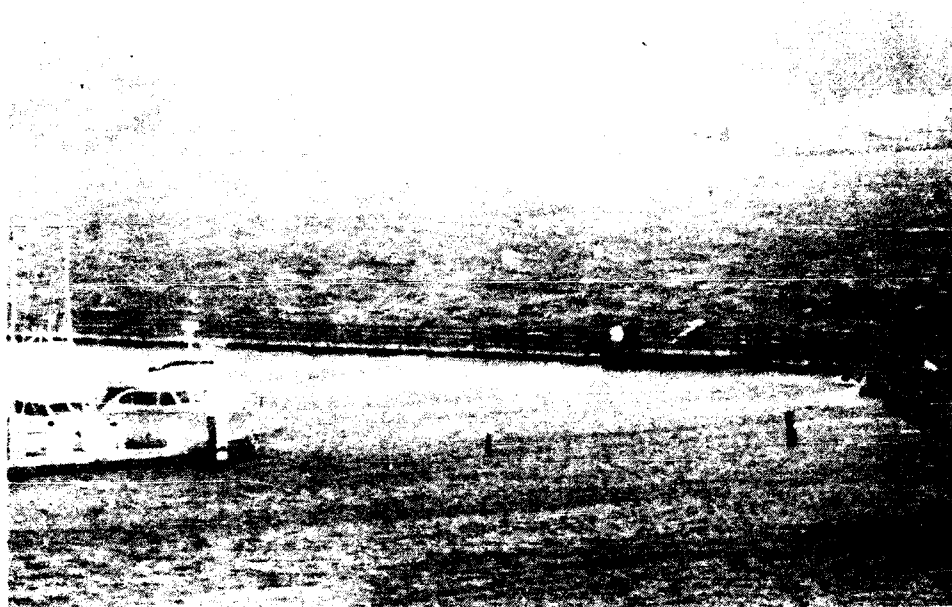
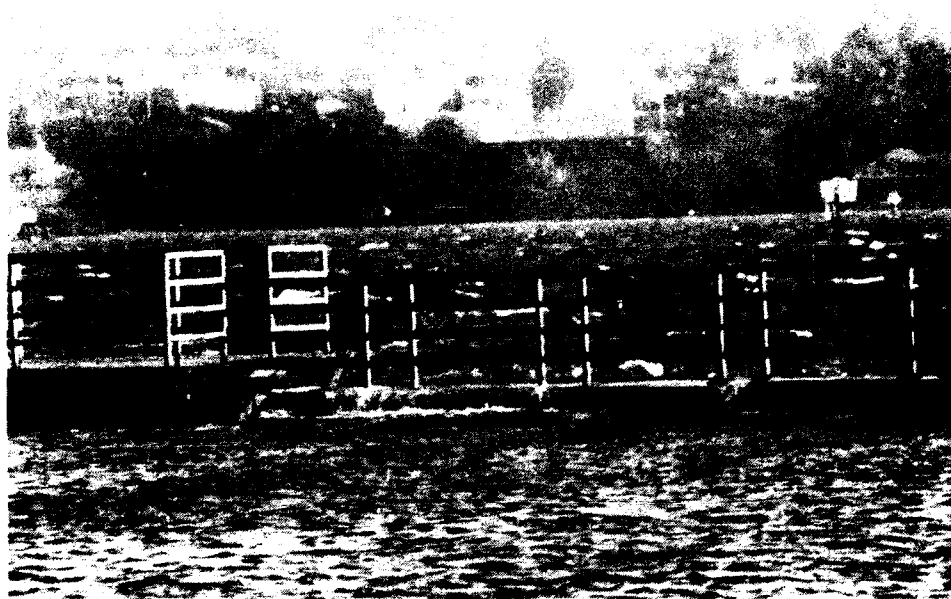
wake large enough to penetrate the breakwater and cause rolling of the docked boats. Figure 19 (a - f) is convincing evidence of the breakwater's wind wave attenuation performance under severe conditions. Even with overtopping, the water inside the marina remained calm.

Figure 19. Breakwater in storm conditions at high tide (Sheet 1 of 3)
